# Refinement of Propellant Strand Burning Method to Suit Aluminised Composite Rocket Propellant

*Paul C. Smith, Garry Hale and Raoul A. Pietrobon*

DSTO-TN-1396

# Refinement of Propellant Strand Preparation and Burning to Suit Aluminised Composite Rocket Propellant

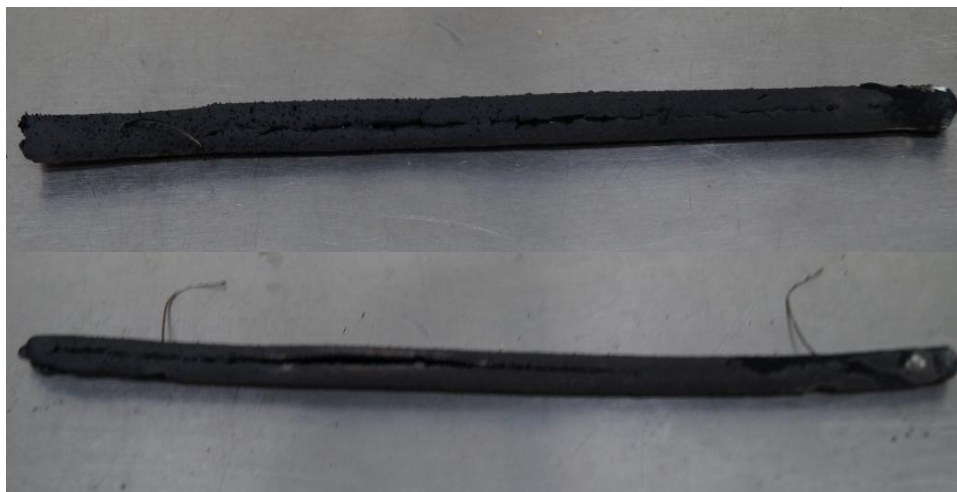
Figure 5: Burned strands showing splits in the coating – 4.09 MPa (top) and 8.01 MPa

combustion revealed splits in the paint coating (paint shell) for a significant length of each strand (Figure 5). It is thought that either the paint coating was flawed or the internal pressure created by the burning propellant caused the coating split. This would allow the flame to run down the longitudinal faces of the strand resulting in an artificial elevation of the burn rate.
